DET NORSKE VERITAS

Final Report

Dissecting Coating Disbondments

Report No./DNV Reg No.: ENAUS 811 Brossia (101131)
Rev 1

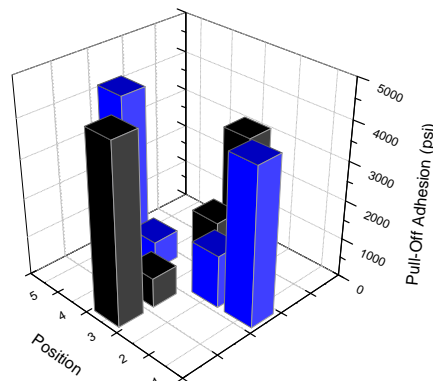
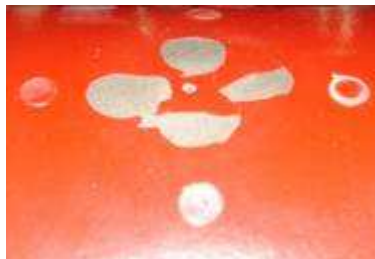
Figure 17. As-received Section #A: a) adhesion strength and b) surface after pull-off test

As seen in Figure 17 and Figure 18, the adhesion strength of the coating near the defect decreased from about 4000 psi to less than 1800 psi after exposure. The dollies placed in the proximities of the defect were included within the area that was covered by the acrylic cell during the CDT. However, as seen in Figure 18, coating failure also occurred outside the exposure region. That is, the failure zone extended beyond the actual exposed area for the CDT. This observation combined with the fact that no coating failure occurred on the tests before exposure seems to indicate that the extension of the coating damage was not confined to the region exposed to the soil environment.

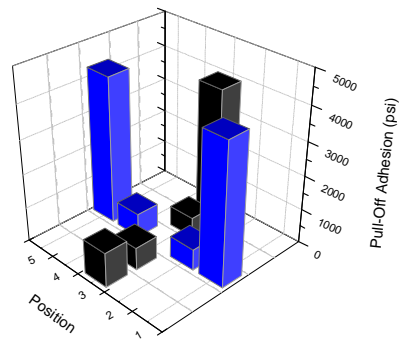
Figure 18. As-received Section #B: a) adhesion strength and b) surface after pull-off test

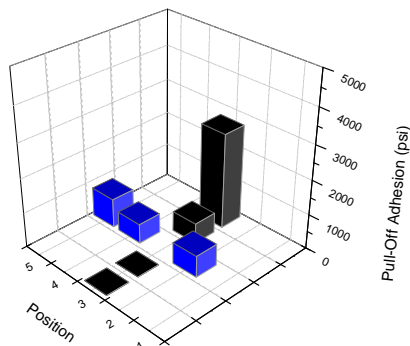
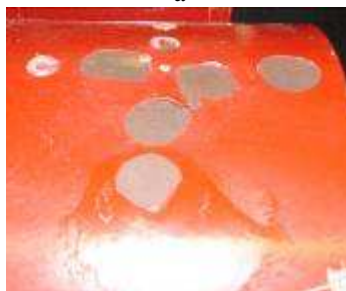
Figure 19. Chloride Contamination Section #A: a) adhesion strength and b) surface after pull-off test

As seen in Figure 19 and Figure 20, the adhesion strength measured on the samples that were pre-treated with chloride was the lowest. No significant changes were found in the surface chloride measurements after testing and the pH at the surface of the pipe and at the failed coating were close to neutral. After pull-off adhesion measurements, the coating was gently scraped with a utility knife and the pH measured at various locations. As shown in Figure 28, almost the entire coating was removed by the knife. In this case, however, this was not necessarily caused by the CDT since adhesion was affected by the pre-treatment as evidenced by the initial low strengths

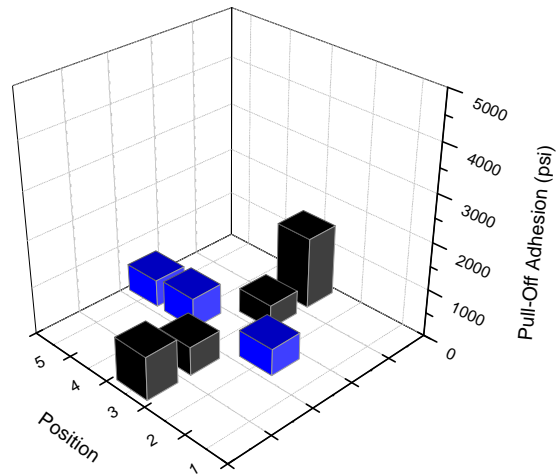
Figure 20. . Chloride Contamination Section #B: adhesion strength

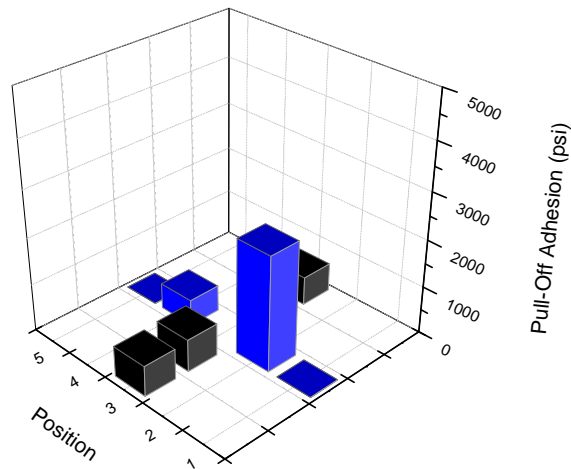
Figure 21. Oxide Contamination Section #A: adhesion strength.

Similar results were obtained for mud/grease and oxide pre-treatments. In both cases adhesion strength was in between the as-received and chloride cases as illustrated in Figure 21 to Figure 24. Measurements of surface pH and chloride content were also in line with previous findings. Removal of the coatings by scraping revealed that the pH increased to values near 10-11 only at locations near the defects. Removal of the coatings was almost complete. As in the chloride pre-treatment case, this was not necessarily caused by the CDT but by the lower adhesion strength of the FBE coating as a consequence of having a contaminated surface prior to coating application.

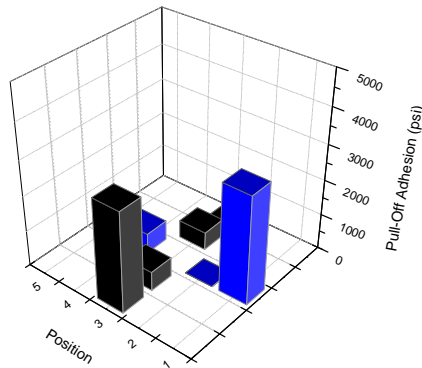
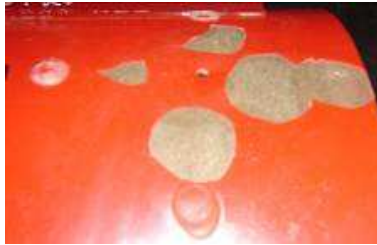
Figure 22. Oxide Contamination Section #B: a) adhesion strength and b) surface after pull-off test

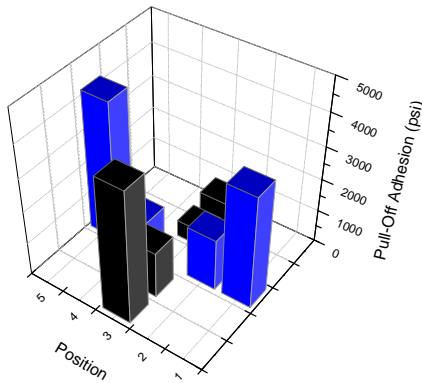
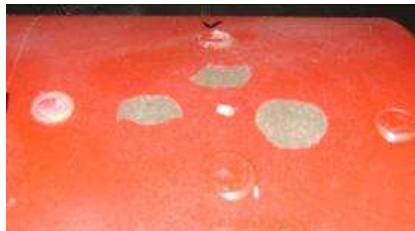
Figure 23. Mud/Grease Contamination Section #A: a) adhesion strength and b) surface after pull-off test

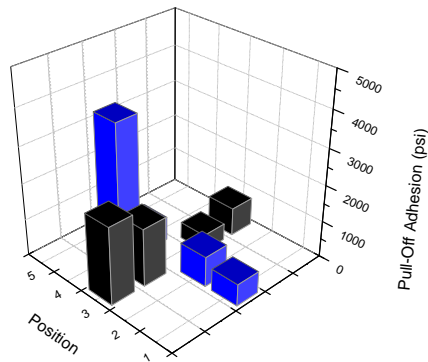
Figure 24. Mud/Grease Contamination Section #A: a) adhesion strength and b) surface after pull-off test

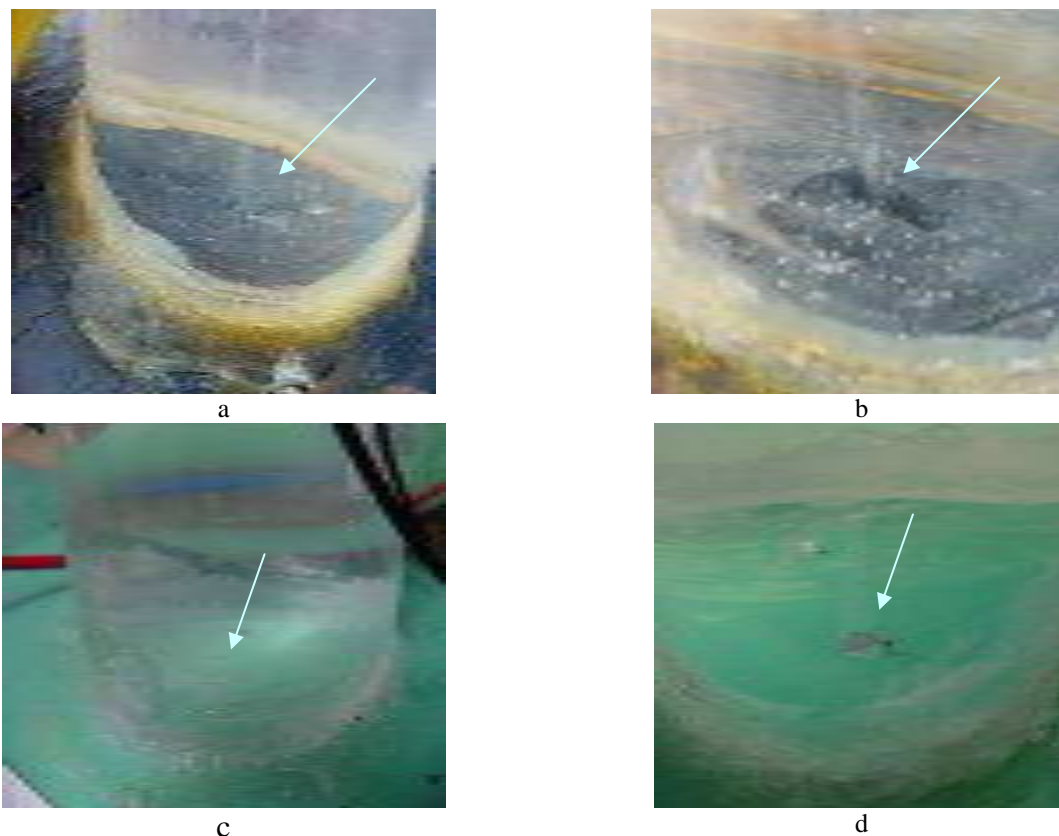
A total of 8 pipe samples were tested: 2 FBE, 4 CT, and 2 RCT with average service lives greater than 15 years. Two cells (one with NaCl solution and one with soil) were attached to each pipe sample. In NaCl, gas (hydrogen) evolution occurred immediately after connecting the steel pipe to the Mg anode, as shown in Figure 29.

Figure 29. Gas (hydrogen) evolution is witnessed by the formation of bubbles at the holiday after connecting the steel substrate with the Mg sacrificial anode for Coal Tar in a) and b) and on FBE in c) and d).

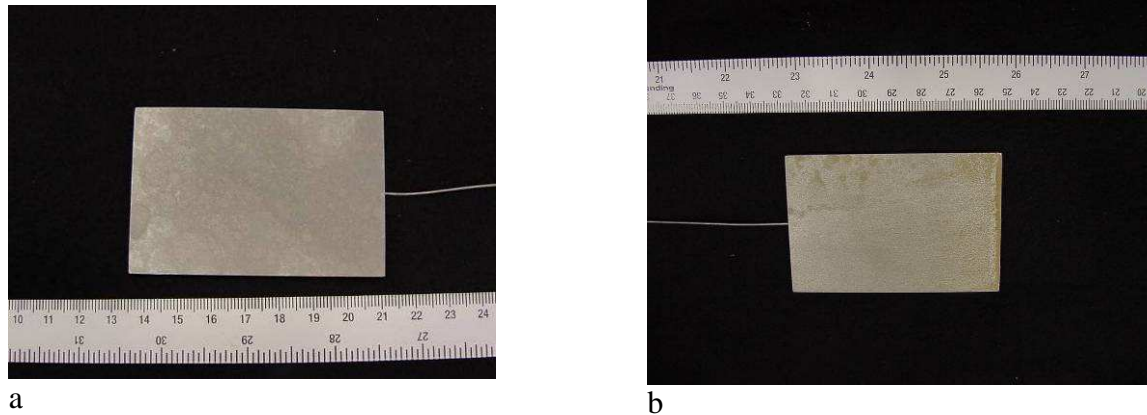
Figure 34. Visual appearance of sand blasted coupons after: a) chloride and b) mud contamination

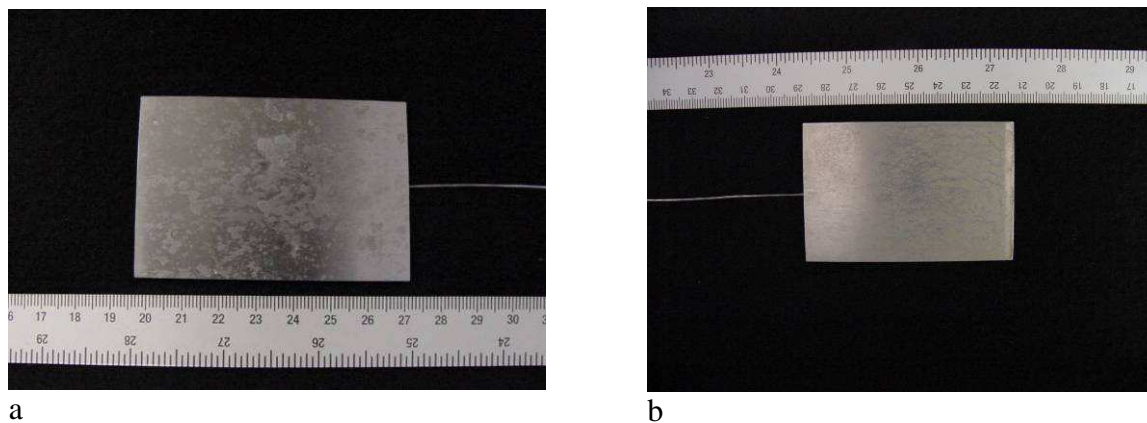
Figure 35. Visual appearance of 600 grit coupons after: a) chloride and b) mud contamination

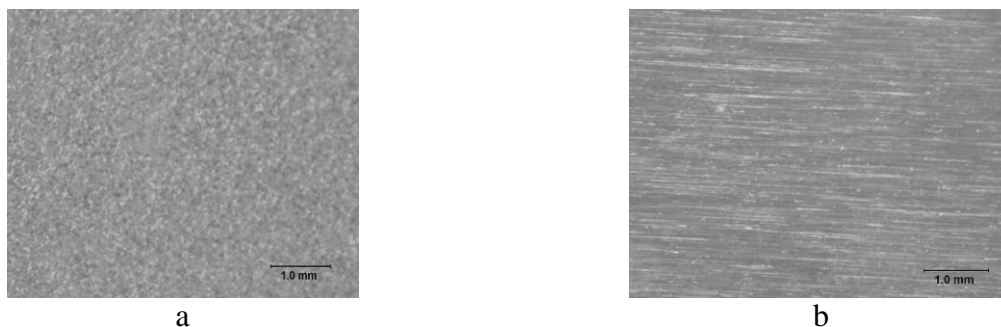
After pre-treatment, a set of samples was analyzed following the standardized procedure described previously. Table 24 summarizes the average chloride and pH values for the different pre-treatments. Surfaces were also replicated using the Struers Repliset kit for posterior analysis. Figure 36 shows the differences in surface topography as evidenced by optical microscopy.

Figure 36. Optical stereo-micrographs of the replicated surface of: a) sand blast and b) 600 grit coupons.

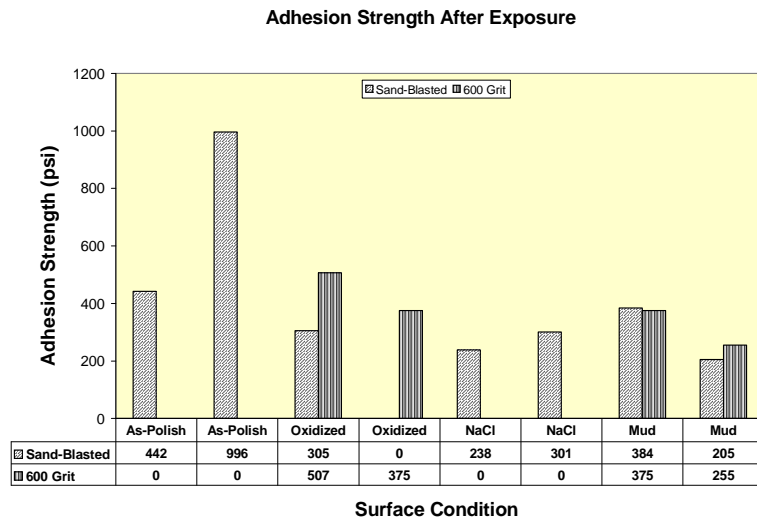
Figure 41. Adhesion strength as a function of surface pre-treatment.

The first observation to make is that the adhesion strength of this type of epoxy coating was significantly lower than what was seen for FBE samples. The maximum adhesion strength after testing reached only 1000 psi on a sand blasted surface with no pre-treatment, which would be considered to be the most ideal case. Furthermore, several samples failed during setup, indicating that the coatings were completely disbonded even prior to the initiation of testing. With this caveat in mind, the as-received white sand blast sample showed the highest adhesion strength. Likewise, chloride surface contamination consistently gave the lowest values.

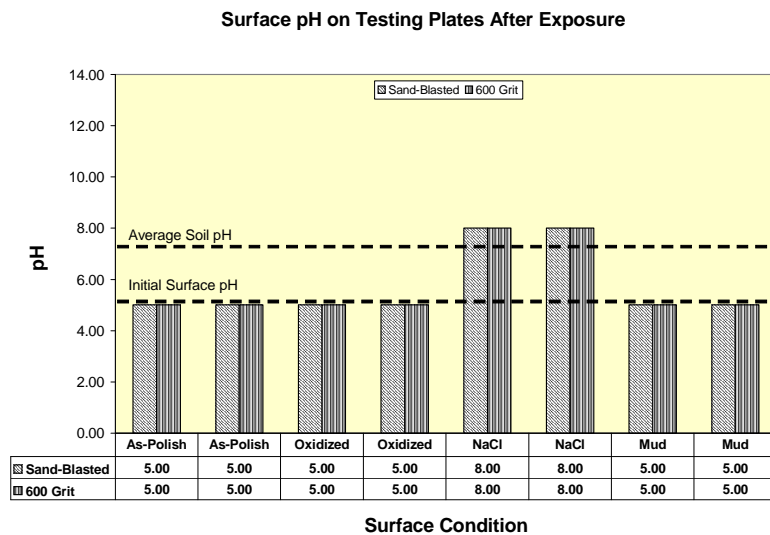
Figure 42. Surface pH on testing plates as a function of surface pre-treatment.

The surface chemistry analysis was in line with the data presented so far. The pH was approximately neutral, except for the intentional chloride contamination surface pre-treatment where the pH was 8. However, no changes in surface chloride were observed after exposure.

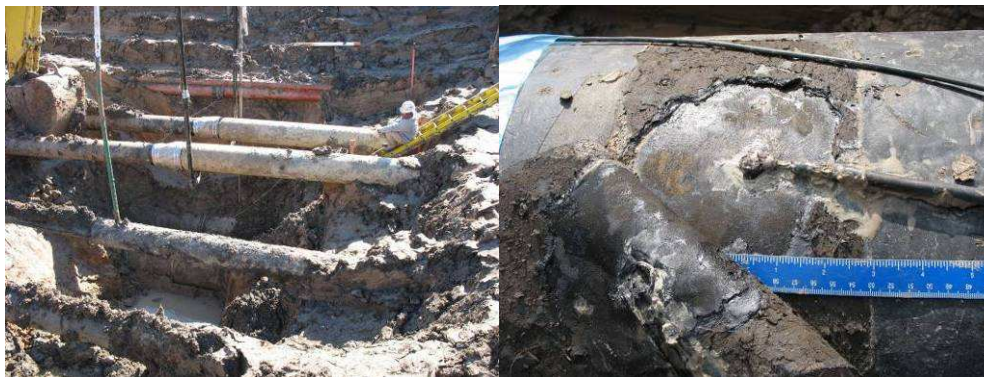
In order to improve confidence and validate the procedure developed to assess laboratory applied coatings, on-site evaluations of in-service pipeline coating disbondments were conducted. The first excavation took place in Louisiana during the first week of January 2007. According to the data surveyed by DNV Columbus, the site presented signs of possible coating failure. Even when signs of coating failure were encountered as seen in Figure 45, the location and the wrinkled conditions of the coating made adhesion measurements impossible. Even though no tests were conducted, this experience showed the typical difficulties that on-site analysis could face.

Figure 45. General and specific view of the excavation conducted by DNV COLUMBUS in Louisiana during January 2007

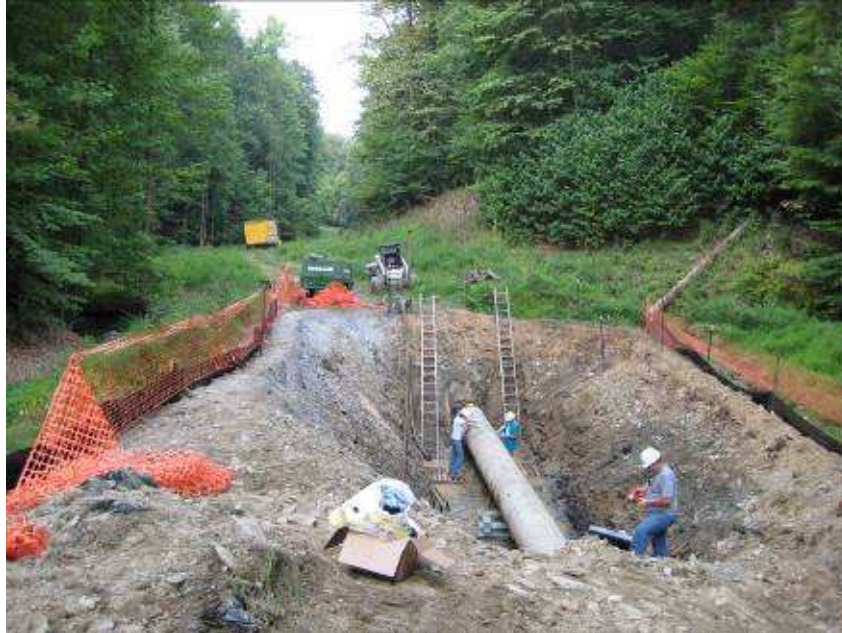
The second excavation took place in Maryland during August 2007. This pipeline transported liquid petroleum and had an estimated age of over 50 years. The pipe had a coal tar enamel coating and aboveground potential surveys suggested that coating disbondments were present. A picture of the site prior to analysis is shown in Figure 46. The pipe was scheduled to be recoated. The analysis was coordinated to take place before the removal of the entire coating.

Figure 46. Pipe section before analysis.

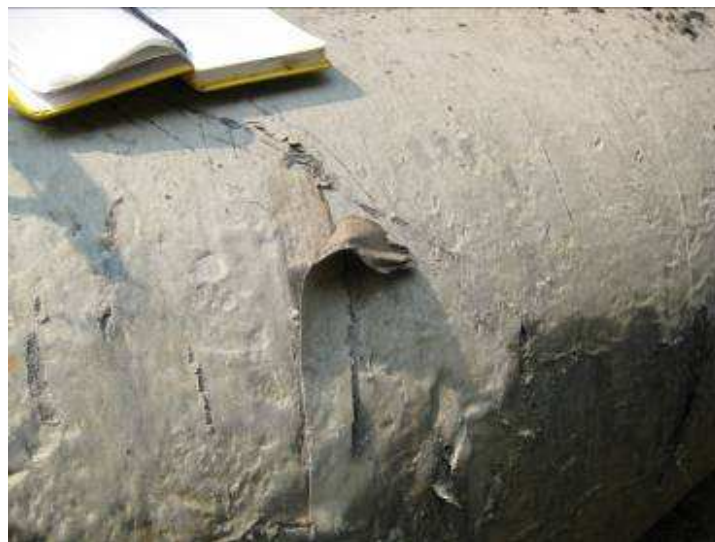
Figure 47. Tape covering the coal tar surface was removed before testing.

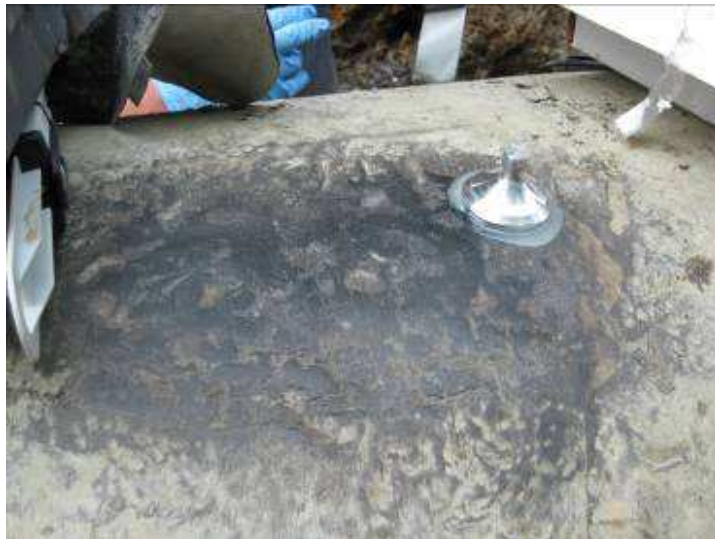
Figure 48. 50 mm dolly applied at the 12 o'clock position.
